Cranwell Flooding

January 2024

Tuesday 9th January 10:00 Holm Farm

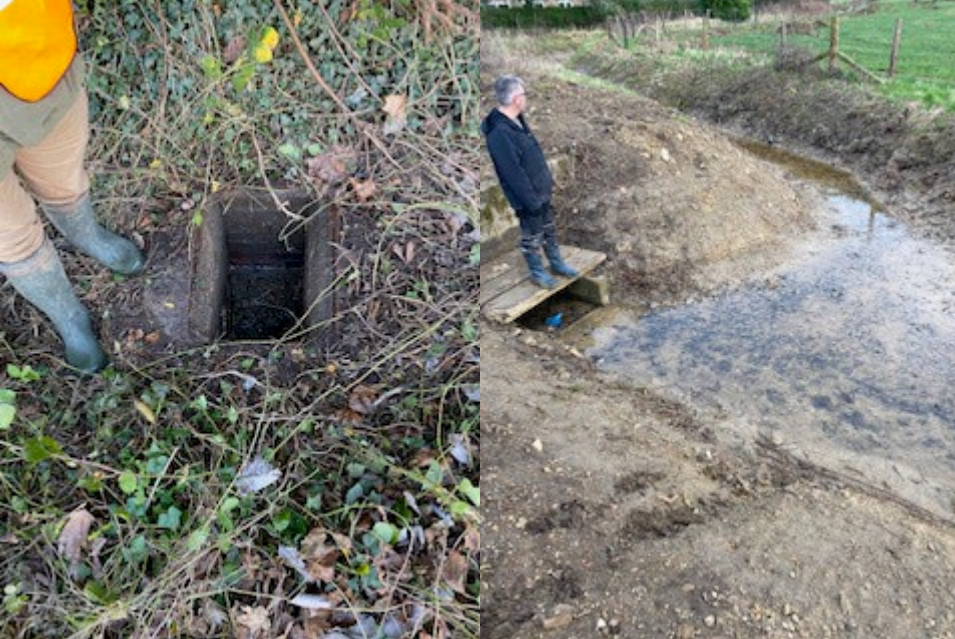
A brick sump was uncovered in the dyke running along the south side of College Road. However, it has not been established where on the N side of College Rd it feeds into the Dyke. Ownership of the land and dyke on the south side is disputed by LCC so this subject is for further investigation by LCC. The team working Holm Park are to investigate and hopefully clear the sump and drainage system under the road.

College Rd Sump

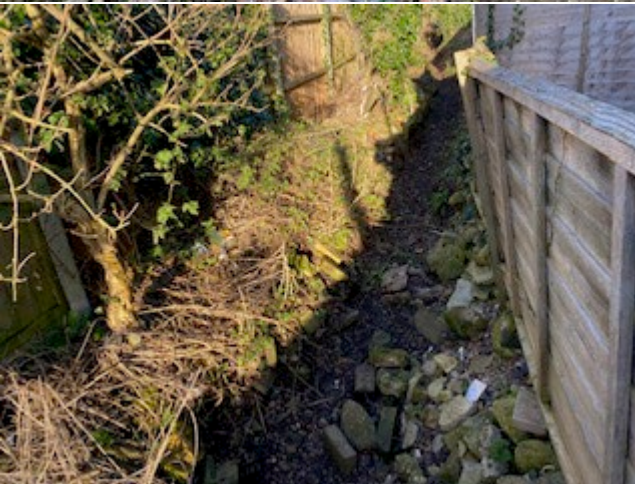
The area of Dyke behind holm park was viewed and dyke clearance was discussed. It is proposed to place a grill at the entrance to the underground pipe which flows under Holm Park to prevent debris and hedge cuttings from entering the drainage system. (Dyson Farming)

Dyk to rear of Holm Park
